## 2014-2015 Wet Weather WQO Ratios for S14 San Gabriel River at SGR Parkway

Figure 4-3.5 S14 San Gabriel River at SGR Parkway Wet Weather Ratio Plots

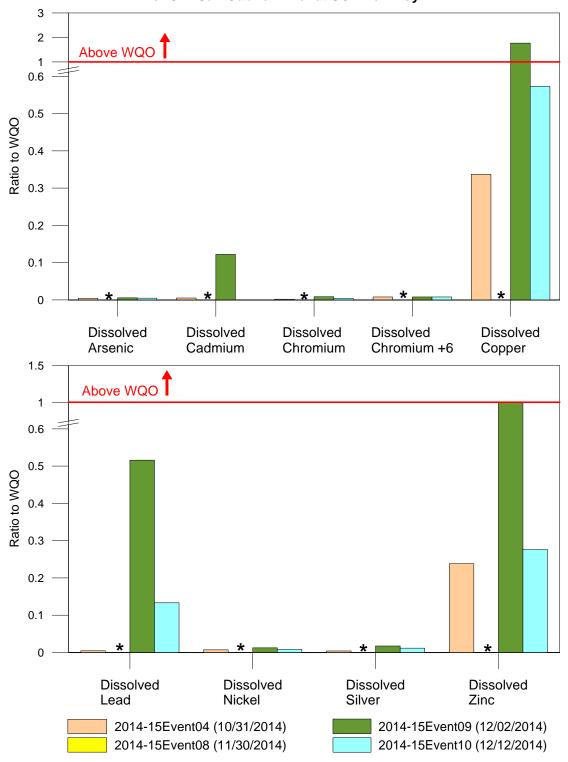
<sup>\*</sup>Samples were not collected for dissolved metals during Event 08.

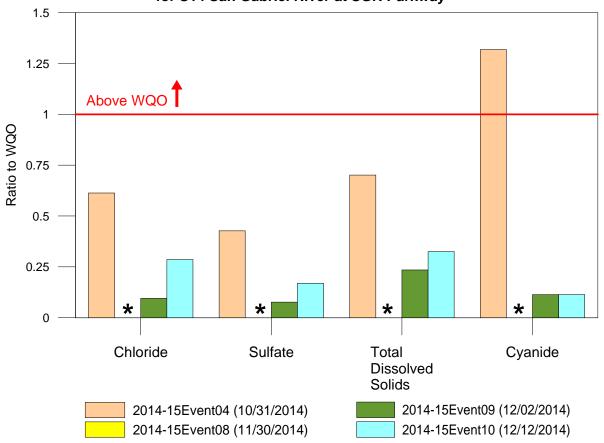
## 2014-2015 Wet Weather WQO Ratios for S14 San Gabriel River at SGR Parkway

<sup>\*</sup>Samples were not collected for chloride, sulfate, total dissolved solids or cyanide during Event 08.

Figure 4-3.5 S14 San Gabriel River at SGR Parkway Wet Weather Ratio Plots

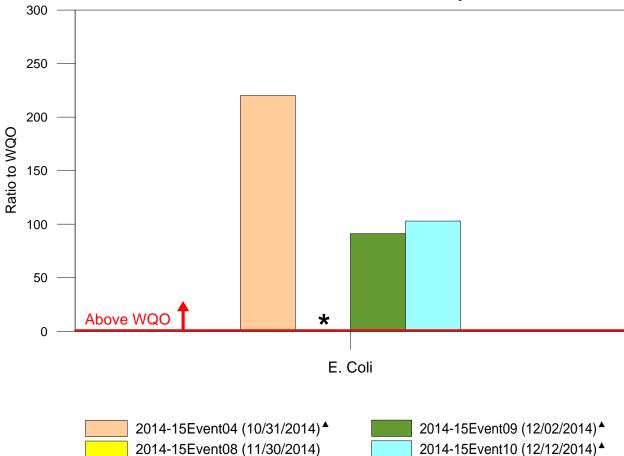
## 2014-2015 Wet Weather WQO Ratios for S14 San Gabriel River at SGR Parkway

<sup>\*</sup>Samples were not collected for fecal coliforms during Event 08.

Figure 4-3.5 S14 San Gabriel River at SGR Parkway Wet Weather Ratio Plots

<sup>▲</sup>Not an exceedance of the E. coli water quality objective due to the High Flow Suspension of Recreational Uses (LARWQCB, 2003).

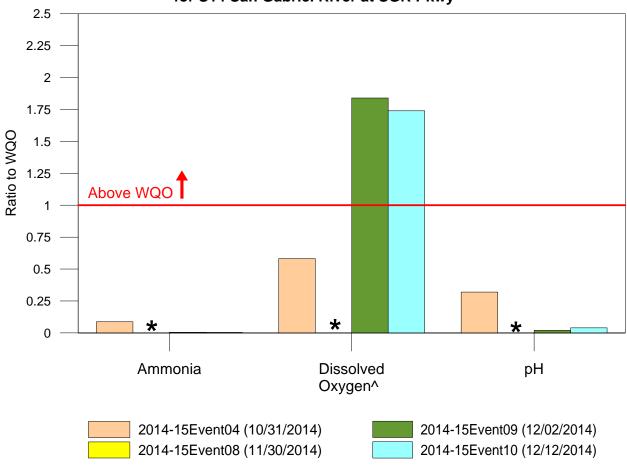
## 2014-2015 Wet Weather WQO Ratios for S14 San Gabriel River at SGR Pkwy

<sup>^</sup>Dissolved oxygen is an exceedance if ratio to WQO is below 1.

Figure 4-3.5 S14 San Gabriel River at SGR Parkway Wet Weather Ratio Plots

<sup>\*</sup>Samples were not collected for ammonia, dissolved oxygen or pH during Event 08.
